## **ARO38: 'A little earth above the stone': Archaeological Investigations 2006–2012 for consolidation work at Moy Castle, Mull, Argyll and Bute**

**By Ray Cachart with an historical account by David R Perry and additional contributions by Tamlin Barton, David Bowler, George Haggarty, Derek Hall, Robin Murdoch, Catherine Smith and Joan A Walsh**

**Published by GUARD Archaeology Ltd, [www.archaeologyreportsonline.com](http://www.archaeologyreportsonline.com)**

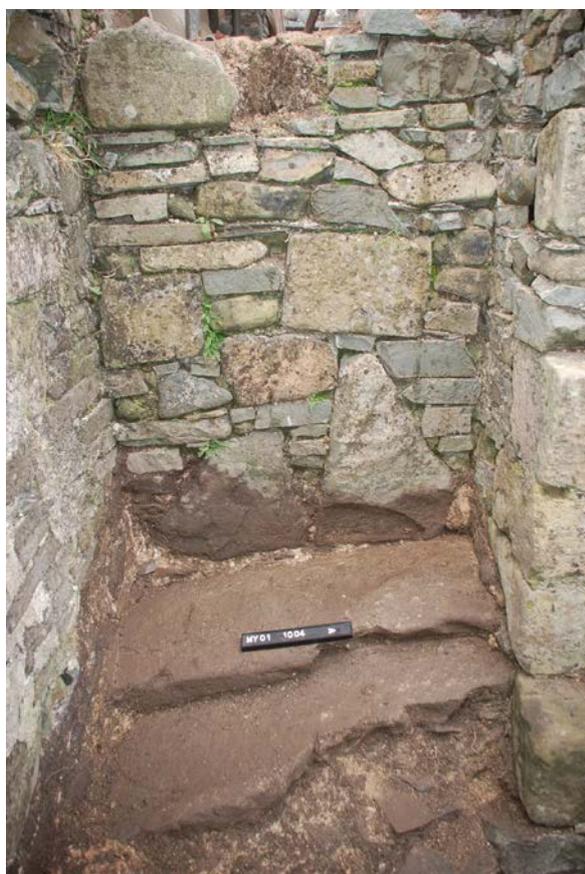
Plate 2: Area 1, sandstone walkway slabs (1004), view W

To the west of the stair, two original sandstone paving slabs (1004) survived in situ (Plate 2). The upper slab is cracked and the lower has a slight bevel on the front edge and a definite channel or runnel cut in the middle, originally to guide rainwater out through the parapet wall. Both slabs have partly broken east edges at their north ends, which seem to reflect the circular stairwell and were probably made to accommodate the remodelling of the area around the stair-head when the caphouse was constructed.

The edges of the slabs formed a pair of steps out of the stairwell and into the passage (Area 8) between the garret gable end and the south parapet wall, but this passage had been blocked off by a stone cross-wall built over the paving slabs (Plate 2).

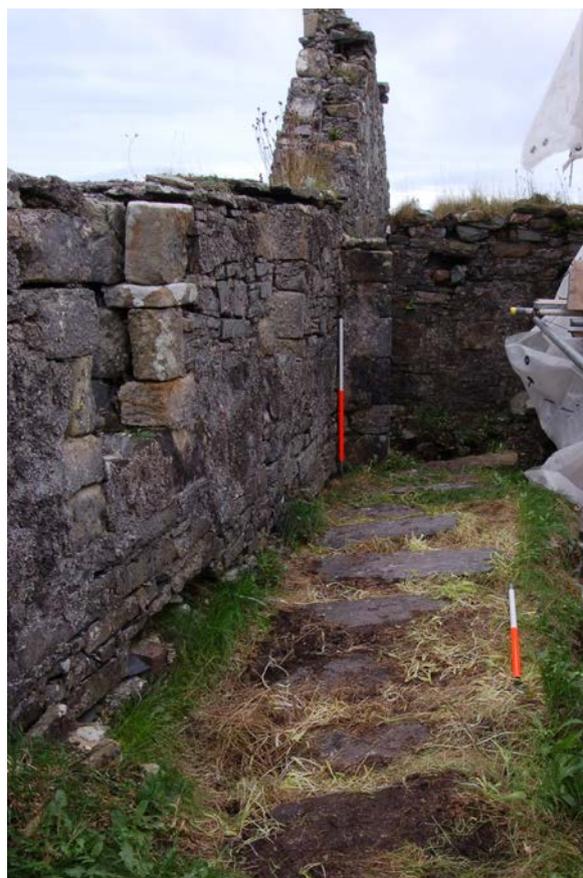
Plate 3: Area 2, pre-excitation: view S

Area 2 was the east parapet walk, from the stair-head (Area 1) to the NE corner turret (Area 3) (Figure 2). Vegetation and silt were cleared to expose a pavement of overlapping slate slabs, arranged so that the gaps between the upper slabs formed drainage channels or runnels. The slabs were 0.30-0.50 m wide, 0.50-1 m long, degraded and friable (Plate 3).

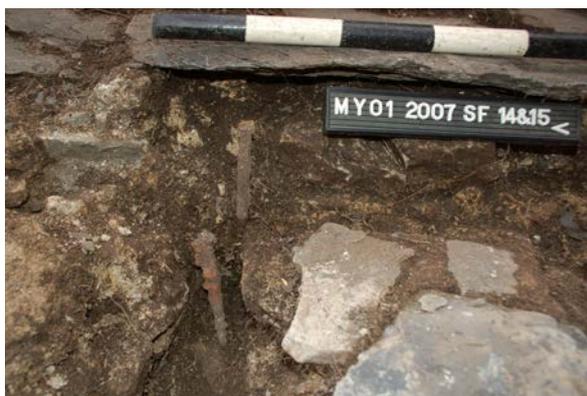
Plate 4: Area 2, angled nails which attached rafter to joist, view E

Between the west edge of the slabs and the inside face of the tower wall, the mortared masonry of the wall head was exposed under turf and silt, in a strip 0.40 m wide. Set into the wall head were slots, roughly 0.20 m deep, 0.12 m wide and 0.30 m long, to receive the ends of the garret floor joists, on to which would have been nailed the rafters. Many of the slots still contained iron nails or spikes in silt, left upright in situ as the beams rotted away (Plate 4). This may signify that the beams and rafters were cut off and taken away, leaving only stumps to rot in the wall head. On the inside face of the garret north gable, the outline of the end rafters could be seen, set at a pitch of 50° (measurements from drawing by Martin Hadlington, Architect, Figure 2).

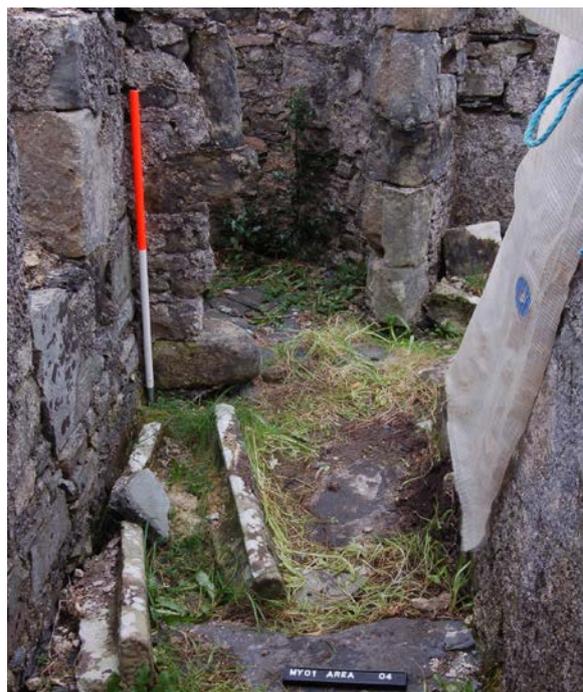
Plate 5: Area 4, pre-excitation: ridging stones (4003) with silt and weeds (4001), view E

Area 4 was the north wall walk between two turrets and between the garret north gable end and the north parapet wall (Figure 2). The wall walk had been substantially narrowed in the middle by the chimney breast of a fireplace (Area 10) inserted in the north gable wall of the garret. On the east side of the chimney was a later doorway into the garret chamber. Over the wall walk was a deposit (4001) of black silt and weeds in the runnels, and with some loose slates and stone fragments (Plate 5).

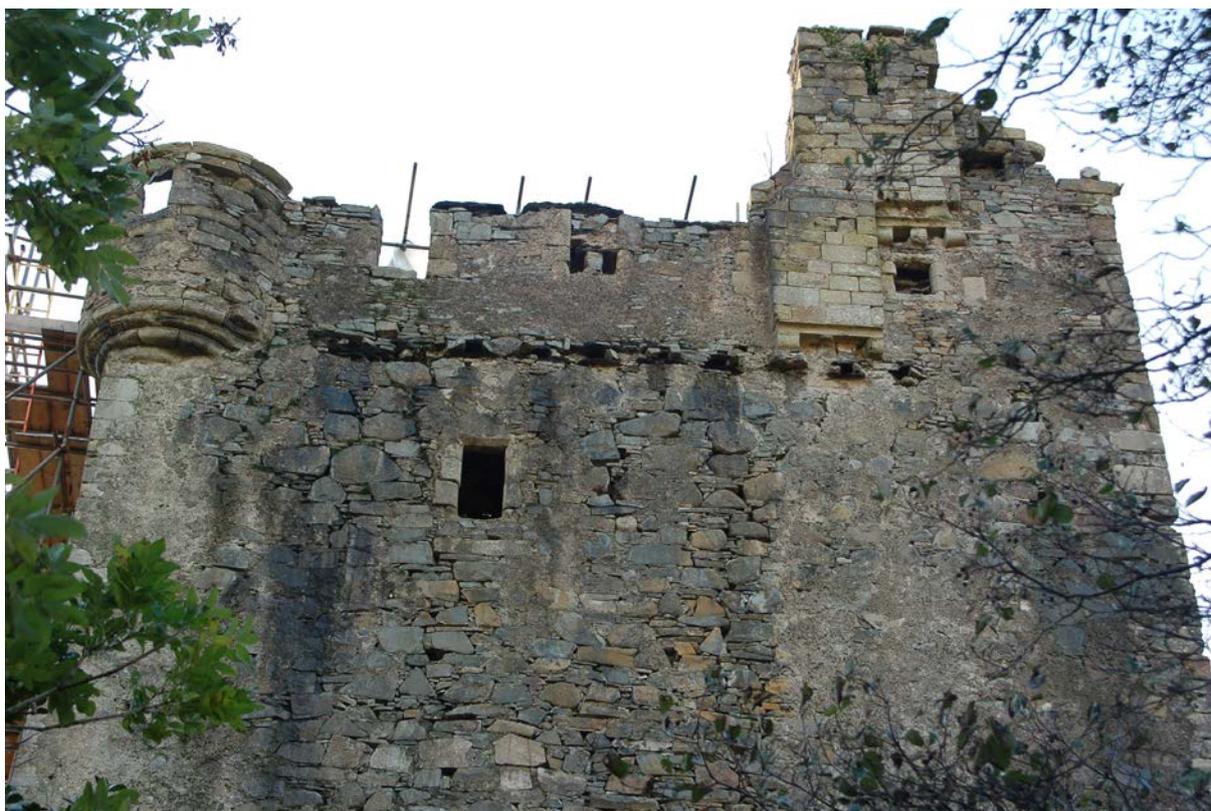
Plate 6: Area 5, north-west turret

Area 5 was the floor of the NW corner turret (Plate 6). The floor was overgrown with weeds and covered in loose roof slates, medium sized stone fragments, mortar and several coping stones, in a matrix of root disturbed silt (5001), about 0.20 m deep. A late nineteenth-century body sherd from a standard white earthenware plate was recovered from (5001). Silt was

removed from a gunloop close to floor level on the east side of the turret; it was positioned to protect the tower entrance. Below (5001) was a floor of flat stone and slate fragments with a large slate threshold (part of an original in situ wall walk slab) measuring 0.4 m by 0.47 m. The floor was uneven, and stepped down approximately 0.20 m below the wall walk surface.

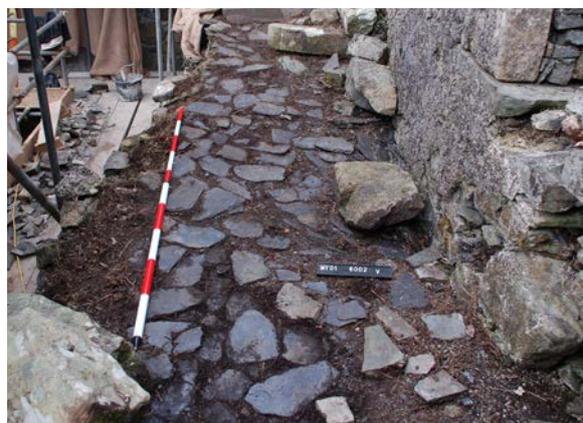
Plate 7: Area 6, slates (6002) on walkway, view S

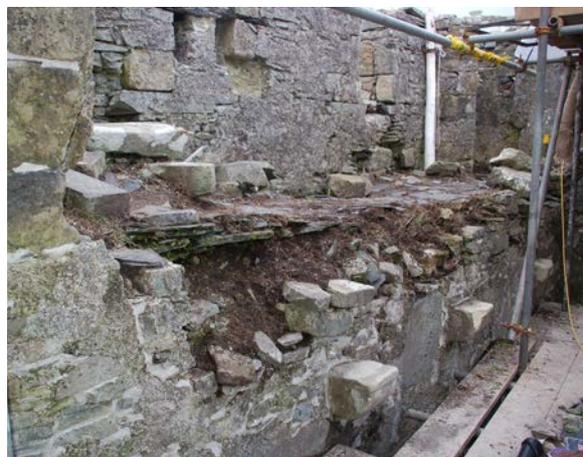
Plate 8: Area 6, corbels for longitudinal beam, view NW

Beneath the east and west wall heads were two rows of five corbels, in opposed pairs, which would have carried longitudinal beams to support the joists from beneath. These did not align with the slots in the wall heads.

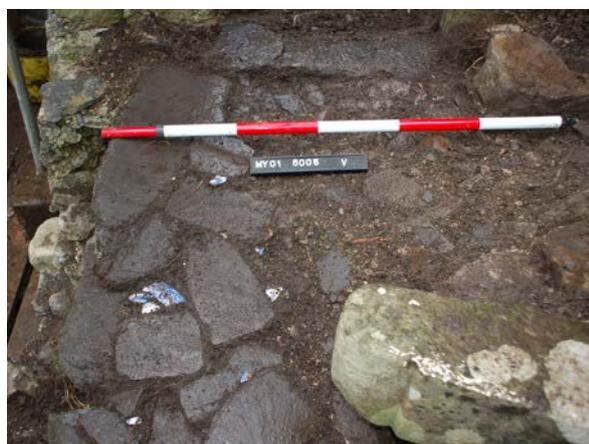
Plate 9: Area 6, pottery sherds, view S

The lower slates of 6002 and slates (6008) were in the runnels of the walkway (6011), and several sherds of nineteenth-century pottery were recovered from these deposits. After the slates had been removed, the walkway and the east edge of the area were cleaned and recorded (Figures 5 and 6). As in Area 2, this exposed a strip of wall head 0.40 m wide (6013) with the slots that held the rafters and floor joists of the garret. Over the wall head was a deposit (6010) of loose grey black silt with occasional mortar, small slate and stone fragments, which had formed within the voids and slots, after dismantling of the garret roof and floor. This deposit (6010) also contained two nineteenth-century Flow Blue pottery sherds (Plate 9). As in Area 2, iron spikes or large nails were found in some of the slots where the wood had rotted (Plate 10).

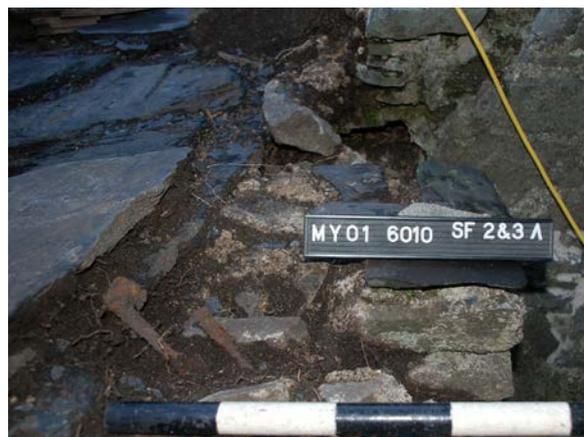
Plate 10: Area 6, angled nails which attached rafter to joist, view N. Silt deposit (6010)

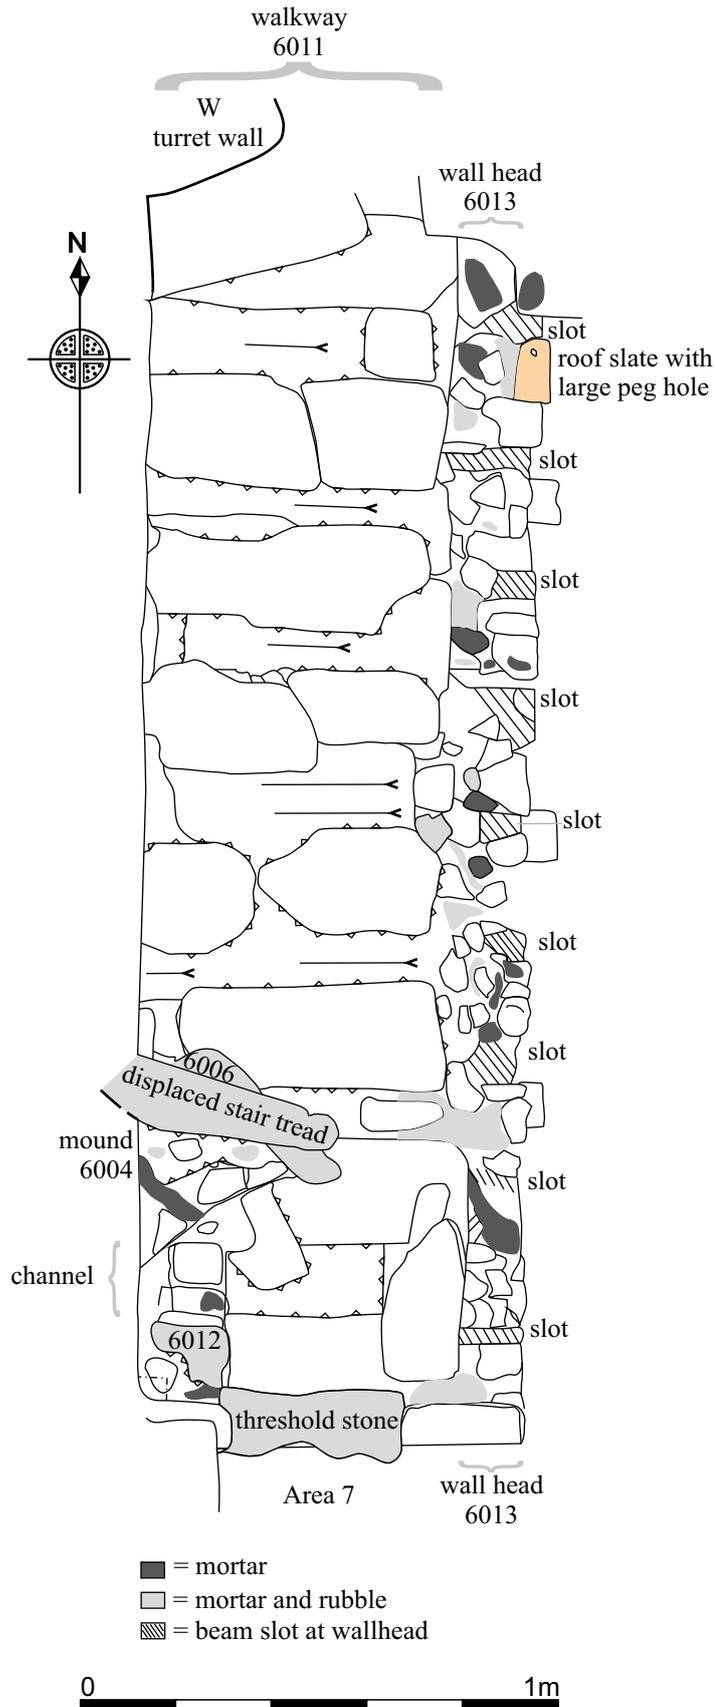
Figure 5: Area 6, west walkway slabs after removal of slates and deposit (6009) showing slots for transverse floor beams

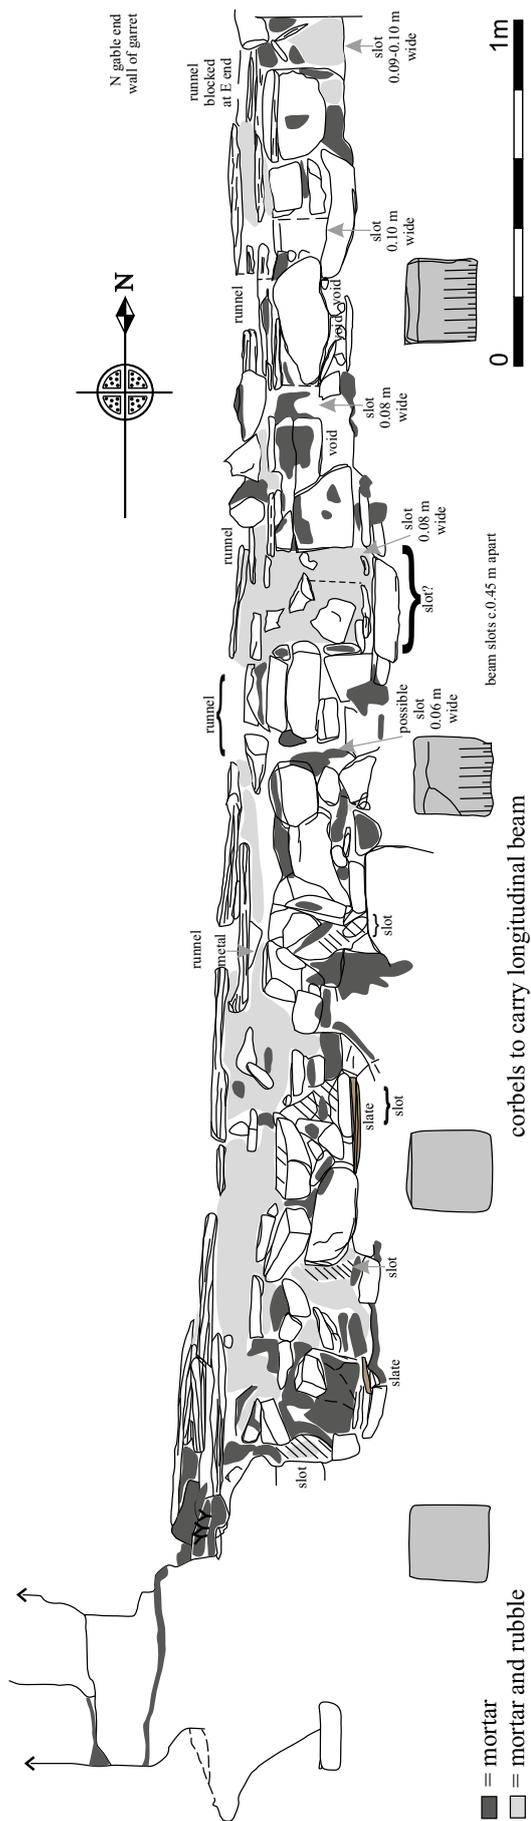
Figure 6: Area 6 east-facing section

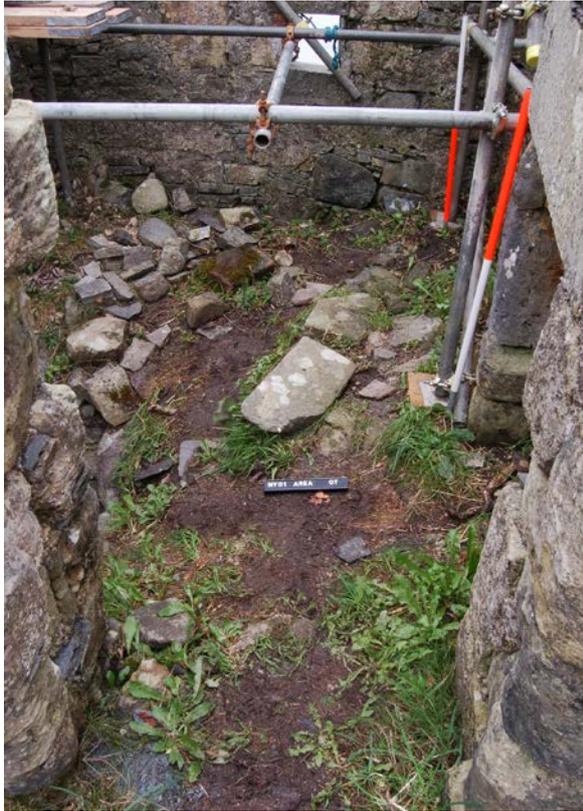
Plate 11: Area 7, pre-excitation doorway, view S

Area 7 was the surface of the lower chamber of the two-storied caphouse at the south end of Area 6 in the SW angle of the tower (Figure 2, Plate 11). In the NW corner of the chamber was a fireplace. The entrance to the caphouse had a slate threshold 0.20 m wide formed from the original walkway slabs. The floor was covered with an accumulation (7001) of stone, mortar and silt, with vegetation (Plate 12). Under this was a debris layer (7002) of slates, mortar and silt with some larger stone fragments (Figure 7). The slates had larger holes than those found in Area 6, indicating that they were fixed with wooden pegs.

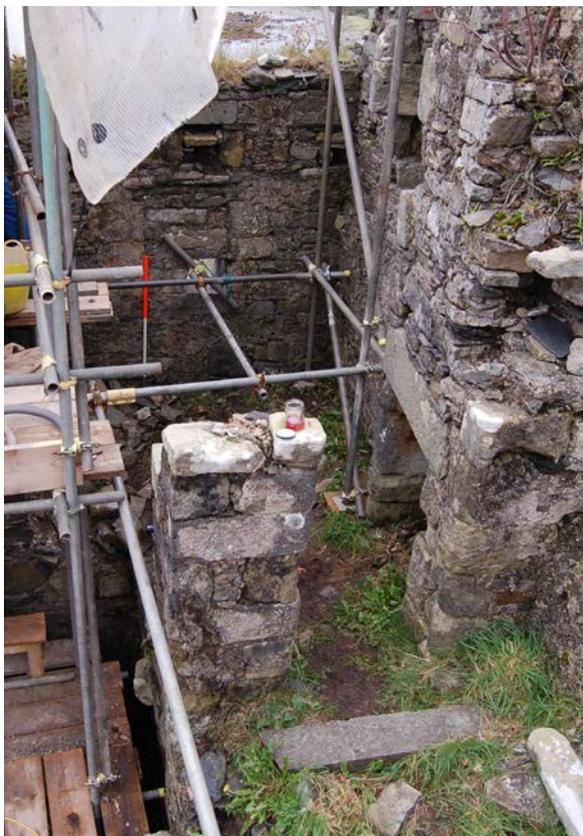
Plate 12: Area 7, pre-excitation floor (7001), view S

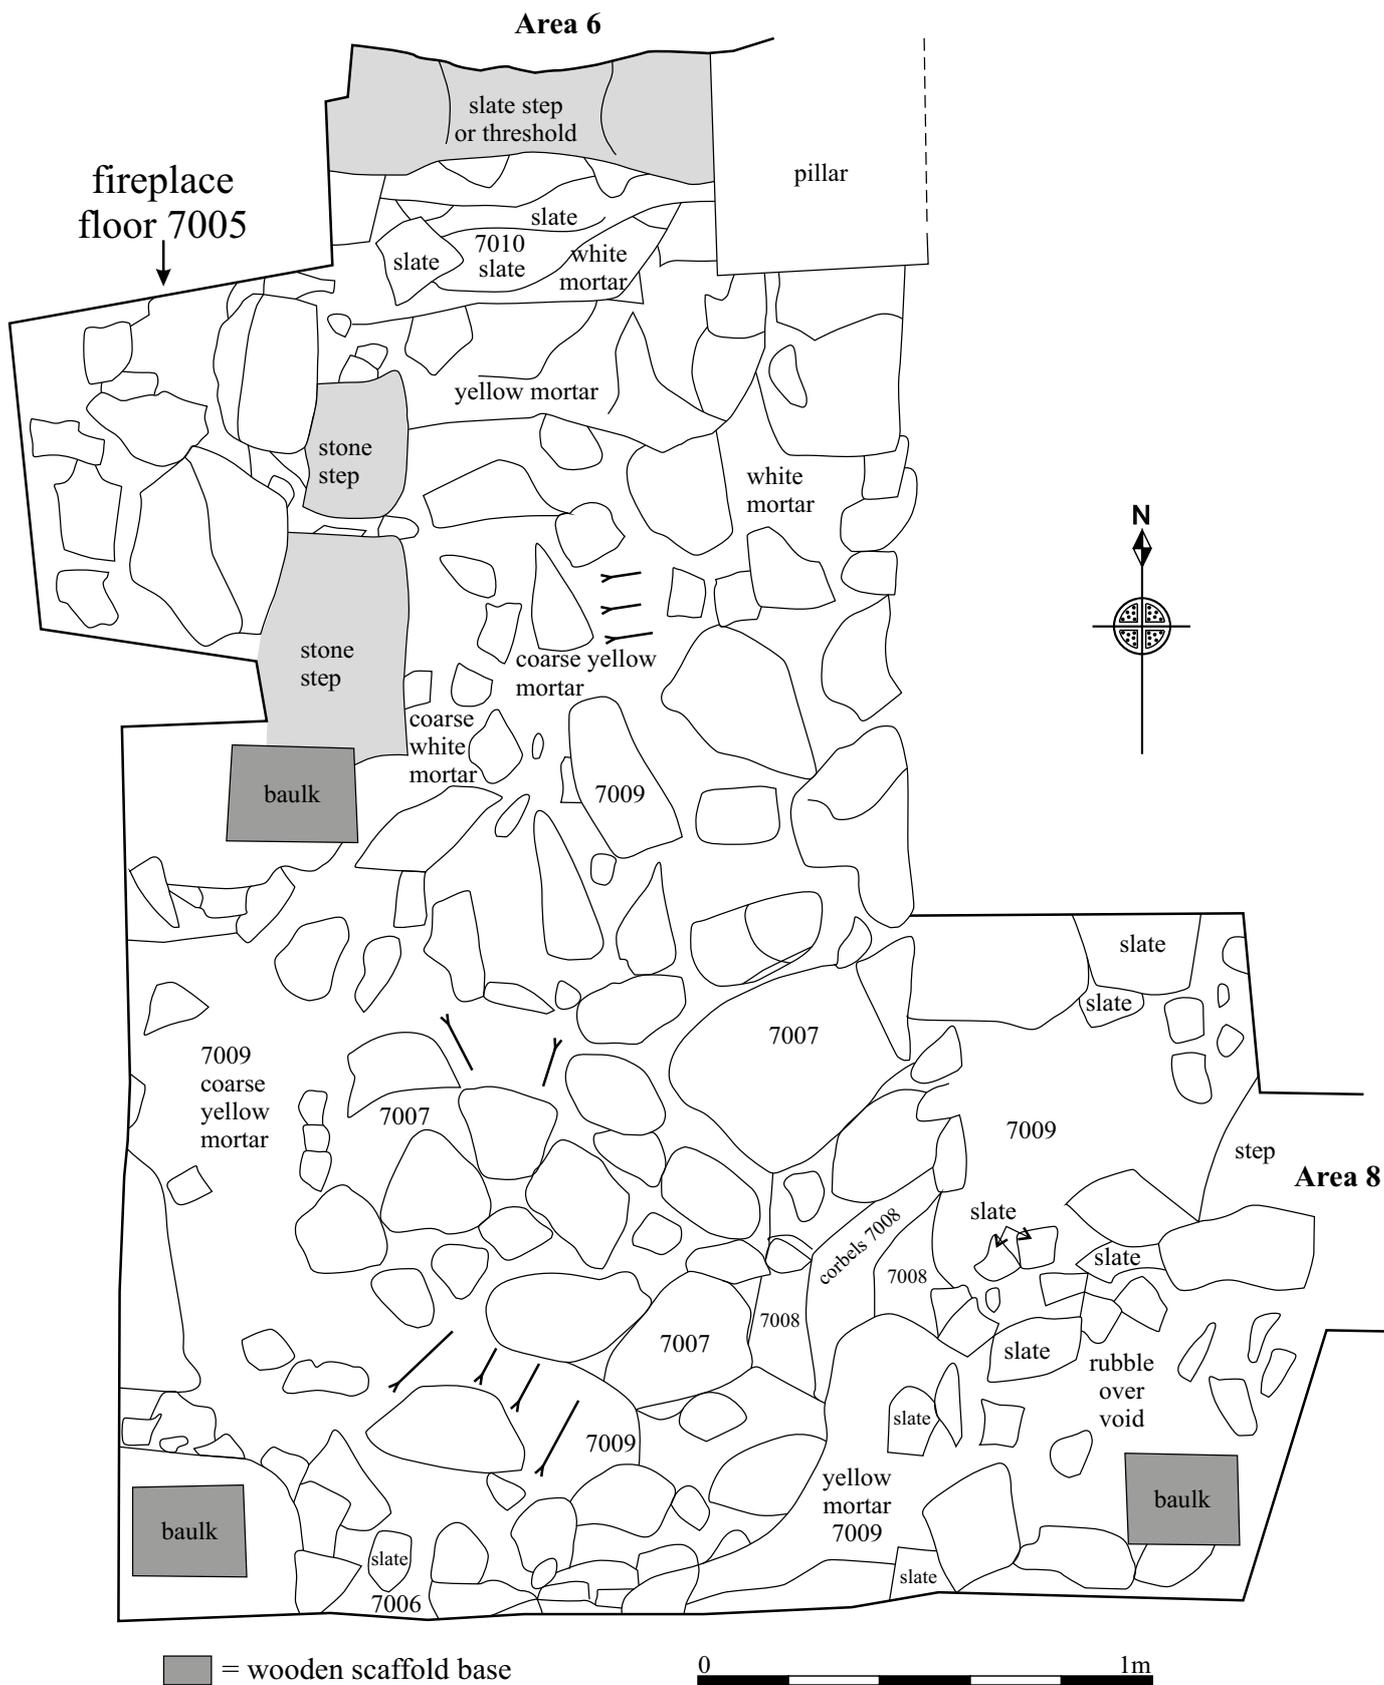
Figure 7: SW [caphouse] Area 7, SW caphouse floor, with cobbles (7007), corbelling (7008) of kitchen fireplace on floor below and wall core (7009)

At the north end of the area, on the south side of the caphouse threshold, slates and irregular stone blocks (7010) had been consolidated with lime mortar to provide support for the caphouse floor and fireplace over the wall core (7009). No original in-situ slate or sandstone walkway slabs were found on the floor and must have been removed when the caphouse was built. The only evidence of a formal caphouse floor was the two flagstones in front of the fireplace. It seems likely that the remainder of the floor was surfaced in this manner but subsequently removed (Figure 7).

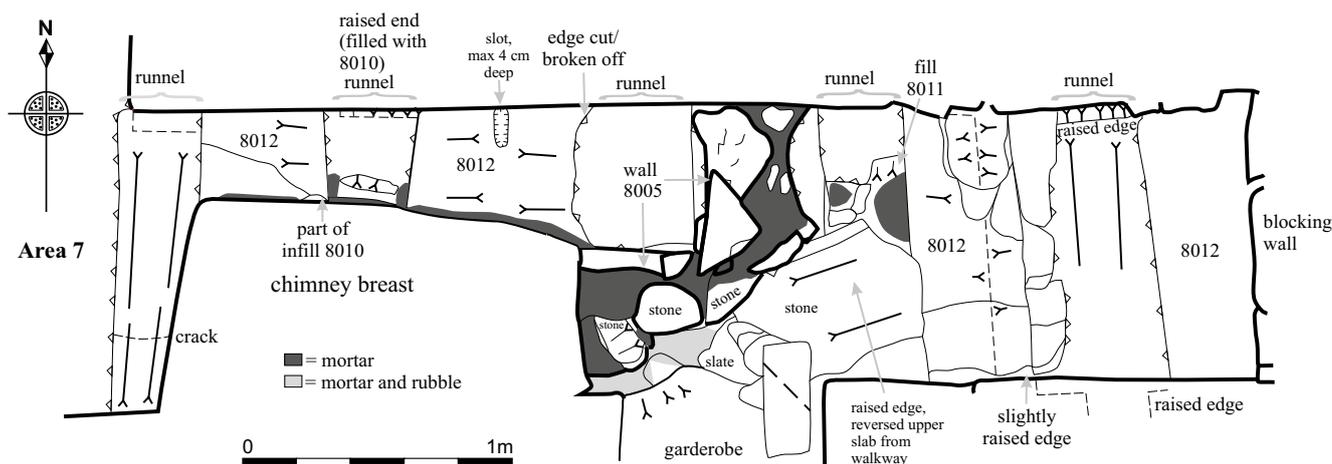
Figure 8: Area 8 floor slabs (8012) and wall (8005)

Area 8 was the passageway between the garret south gable and the south parapet wall on the east side of Area 7 (Figures 2 and 8). Originally, before construction of the caphouses, this was the open south walkway, paved with sandstone slabs. At the east end of this area, a N/S wall had been inserted across the walkway, blocking access to the turnpike stair, Area 1. At the west end of Area 8 was the large chimney breast for the kitchen fireplace on the floor below which restricted the passageway at this location to a width of only 0.40 m. On the east side of the chimney in the south parapet wall were the unstable remains of an open garderobe.

Below the rubble (8001) was a loose deposit of roof slates, powdery mortar and silt (8003), approximately 1.64 m E/W and 1 m N/S. This formed a trampled surface 0.20-0.28 m thick over the original sandstone wallwalk slabs (8012). The slates in this deposit had large peg holes and appear to represent demolition of the roof over this space prior to the dumping of modern rubble.

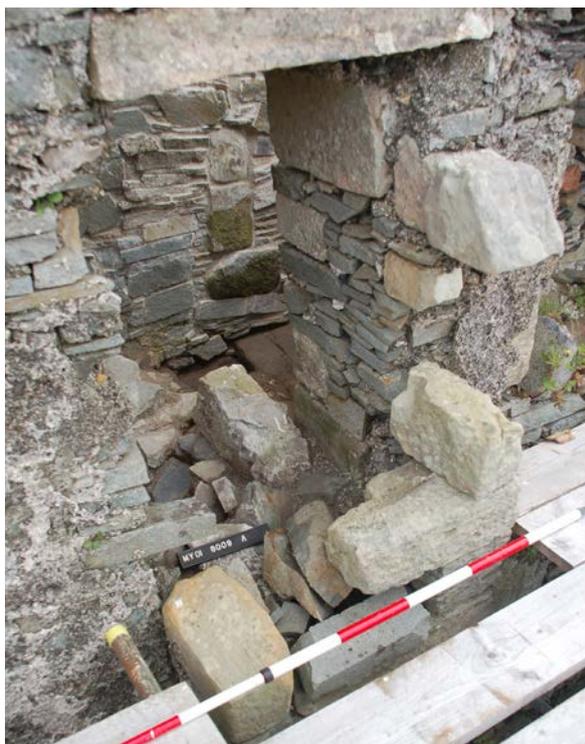
Plate 13: Area 8, exterior remains of garderobe, fill (8009) view NE

The garderope, in the centre of the passageway on the east side of the chimney breast, projected out from the tower south wall face for a distance of 0.40 m at its base. Within this projection loose stone (8008) had accumulated, partly derived from the garderope walls and some of the dumped stone of (8001). On removal of some of this loose stone a nest of dry grass containing abundant small rabbit bones was found, which may indicate that a bird of prey had made use of this feature overlooking the sea. Below (8008) was a lower fill of stone and silt (8009). The large stone in this lowest deposit originated from the partial collapse of the outer structure of the garderope (Plate 13). Deposit (8009) was left in-situ for later consolidation.

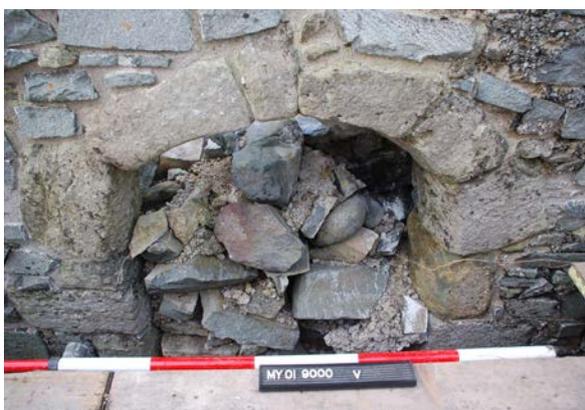
Plate 14: Area 9, blocked doorway, fills (9001) and (9002)

Area 9 was the blocked original arched doorway of the garret in the south gable, 0.80 m wide and 1.30 m high (Figure 2 and Plate 14). Access to this doorway was originally from the turnpike stair in Area 1. The blocking was most likely carried out at the turn of the sixteenth and seventeenth centuries when the caphouses were added. The blocking comprised an upper fill (9001) and a lower fill (9002). The upper fill (9001) contained mortar-bonded medium and smaller rounded cobbles and fragmented stone randomly laid. The lower fill (9002) comprised mainly tabular flat stone fragments laid at random. Below (9002) was an undressed stone sill, 0.60 m long

and up to 0.10 m thick. This does not extend below the jambs on either side and so appears to be part of the infilling (9002). The jambs are built of fine-grained yellow sandstone, some blocks being better dressed than others. The arrises are chamfered slightly on the east jamb but much are more pronounced on the west. The jambs carry a segmented arch with a slightly offset keystone. A split sheep's skull was found in the loose material within the south face of the blocking, possibly carried in by a raptor nesting in the ruined garderobe of the adjacent Area 8. The infilling deposits in the doorway were stabilized and left in situ.

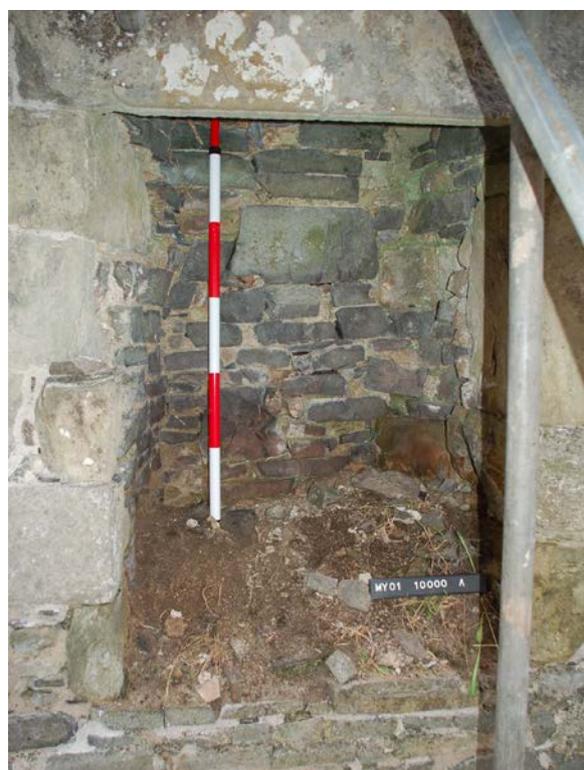
Plate 15: Area 10, north gable fireplace, fills (10001-3)

Area 10 was a small and plain fireplace inserted into the garret north gable wall along with the adjacent doorway (Figure 2, Plate 15) during the improvements at the turn of the sixteenth and seventeenth centuries. The face of the fireplace was 0.89 m across and 0.60 m high, with a depth to the flue back of 0.60 m. Heaped deposits were removed from inside the fireplace. The uppermost deposit (10001) comprised grass and weeds growing in orange/brown silt, over (10002) a similar deposit of orange/brown silt with some small to medium stones, slate fragments and

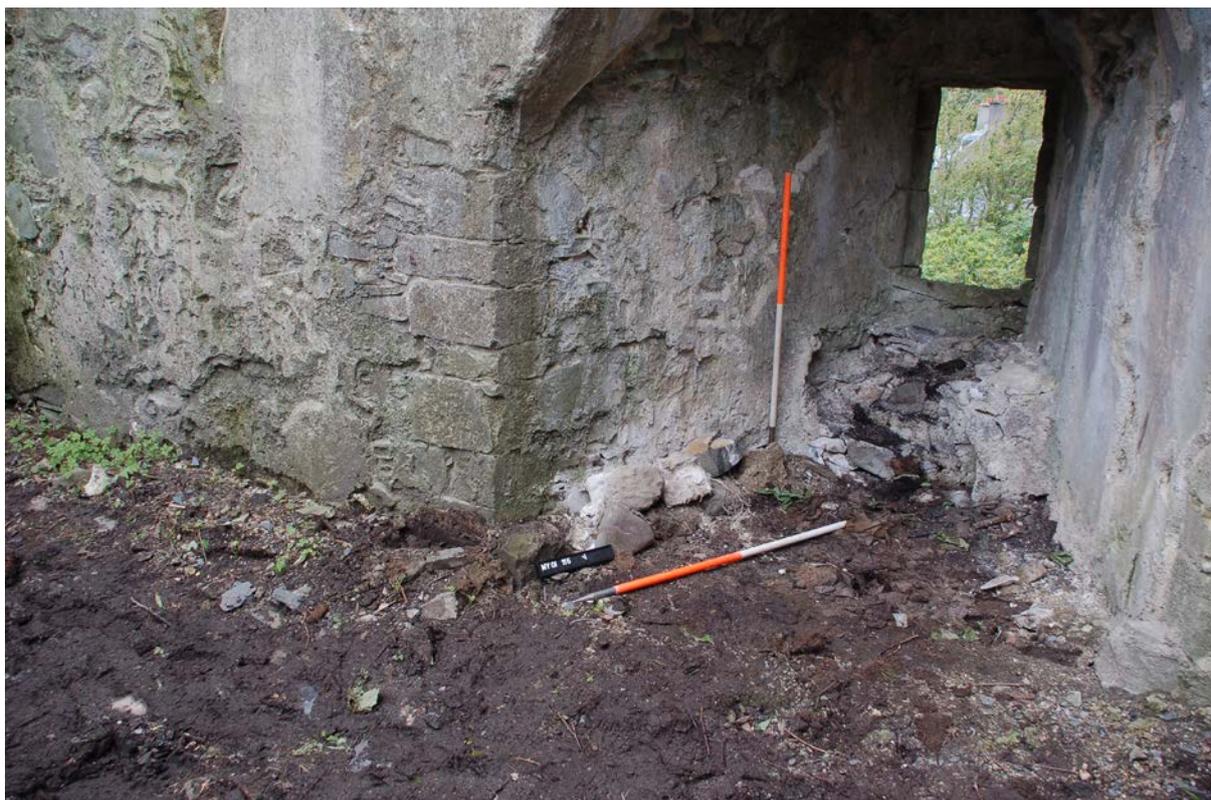
Plate 16: Area 11, west window embrasure, during excavation of Context 118

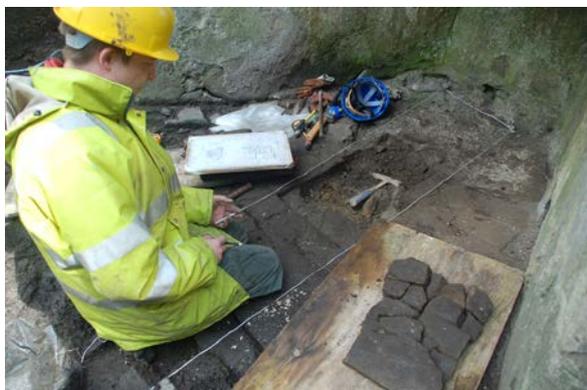
Plate 17: Area 11, kitchen floor, sand (11104), stone (11105), broken slabs (11106)

In the east side of the trench there were surfaces of white mortar (11108), and small cracked and broken flat stones (11105) on mortar, perhaps the original kitchen floor. Farther west was a partly robbed out surface (11106) of small broken flat slabs, laid on a bedding layer of fine grey-brown sand (11104) 0.05 m thick. Under this was a silt layer (11107), 0.17 m thick.

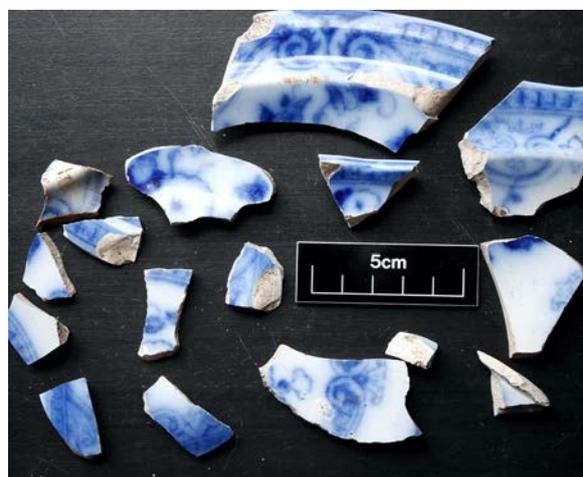
Plate 19: Selection of sherds of Flow Blue from Contexts 6002/6005

Contexts 2001 (Area 2), 5001 (Area 5), 6002, 6003, 6005, 6008 and 6010 (Area 6) produced 46 sherds of a standard white earthenware decorated with cobalt Flow Blue. Several sherds from Area 6 (6002, 6002/6005, 6008) were conjoining and probably came from two different plates (Plates 19 and 20). Flow Blue is a type of transfer pottery produced both in England and Scotland that generally went into production around 1820. It was produced mainly for the US market, where even today it is highly collected. Flow Blue was similar to traditional blue-and-white transfer and hand painted pottery, except that the blue colour was deliberately blurred, an effect achieved by adding a cup of lime or ammonia to the kiln during glazing. The introduction of transferware by the British china industry created a product which was less expensive than imported, hand-painted Chinese and later European ceramics. By the nineteenth century the quality declined making it an affordable product that was very attractive to the surging Victorian working class.

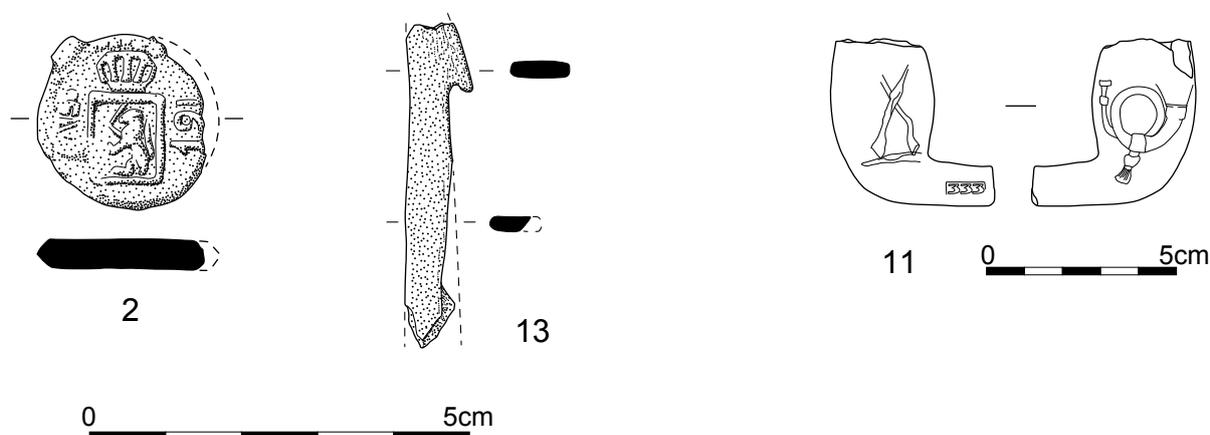
Figure 12: Lead bale seal, Cat 2; clay pipe bowl, Cat 11; bone fish hook, Cat 13

Of particular interest was a lead seal found on surface deposits of the east embrasure. The obverse depicts the crowned shield bearing the lion rampant of the royal arms of Holland (Figure 12). To the right of the shield can be seen what appears to be the number '19', which may be the customs control number. To the left of the shield some markings can be seen but not deciphered. These marks are most likely to represent 'R & A' (Regten en Accynsen = Customs and Excise). The reverse is worn or blank. The seal is a Dutch customs seal, probably from a bale of flax, dating from the nineteenth or twentieth centuries.

Worn sub-circular lead seal bearing lion rampant with crown above, lettering on left (unreadable) and numbering '19 - ' on right. Reverse is worn flat.

A broken fragment of mammalian bone with some polishing thought to be use-wear may be the remains of a fish hook (context 118) (Figure 12).

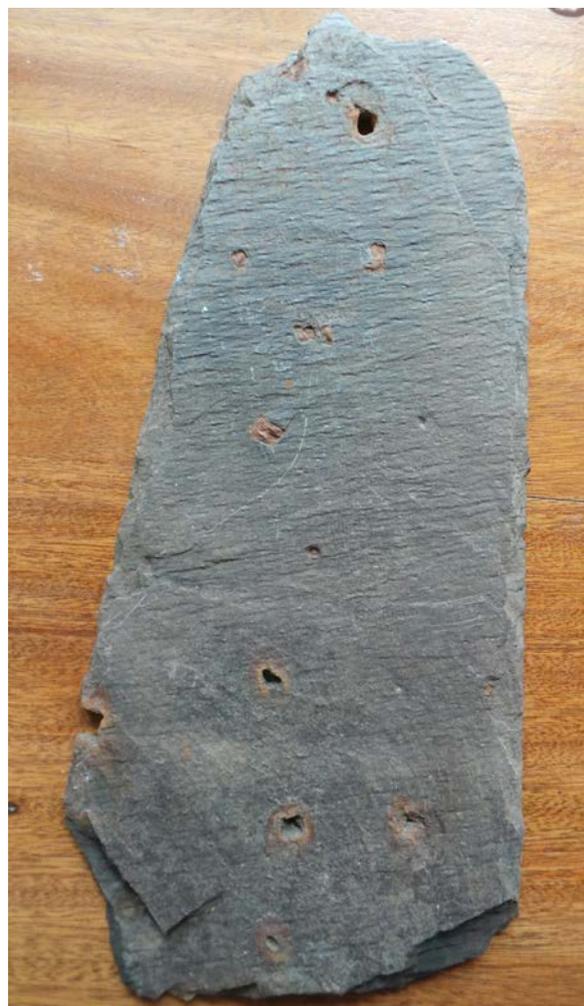
Plate 21: Sample Context 1114 is a fairly regular slate with a small nail hole suitable for a metal nail

*Context 1114:* This is a complete slate, 110 mm in length and 140 mm wide at the bottom, decreasing to 70 mm at the head. It is between 5 mm and 6 mm thick. Pyrite is present as crystalline cubes 3-5 mm in size; voids show where many have fallen out. In spite of this, the slate is in good condition with a good ring tone. There is a single nail-hole, 5 mm in diameter, with a hand cut metal nail *in situ*. This is a fairly regular shaped slate, possibly tapered to fit the roof. There is a small notch on one of the edges, the

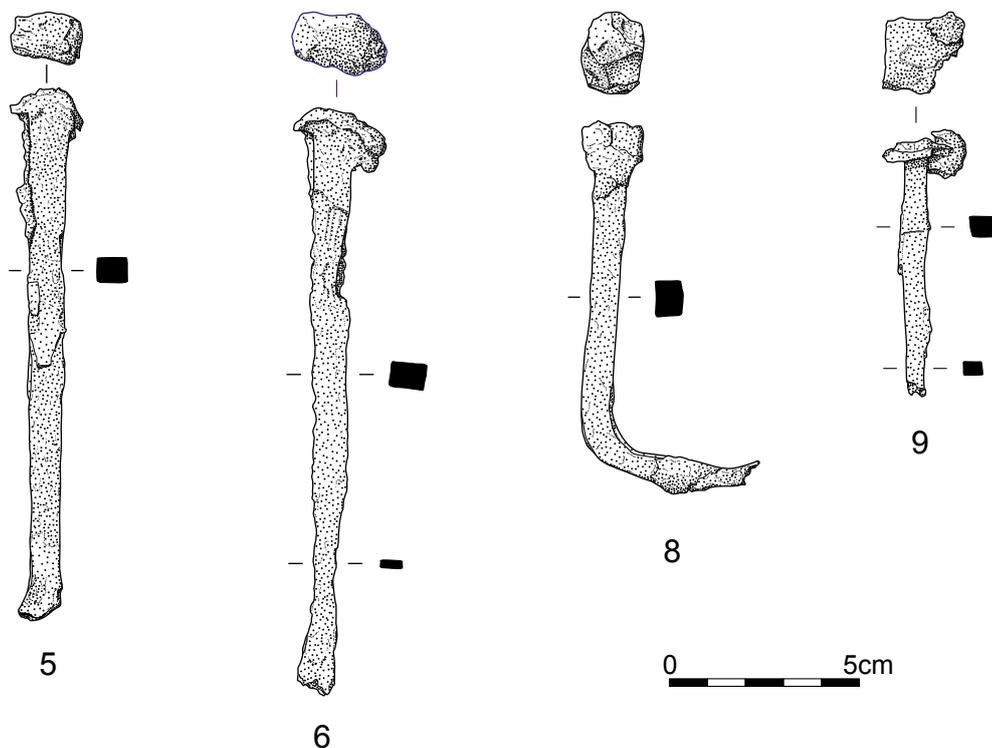
Figure 13: Iron nail, Cat 5; Iron nail, Cat 6; Iron clenched nail, Cat 8; Iron clench bolt with rove plate; Cat 9

One square-headed clench bolt with a square/rectangular rove plate attached was present in Context 1111, (SF 03, Cat 9). Also present was a separate rove plate (Cat 10). Other nails which were either deliberately clenched (or bent accidentally) were noted (e.g. Context 2007, SF 13 was a large hammer-headed long timber nail, the shaft bent back at right-angles to the direction of the shaft).

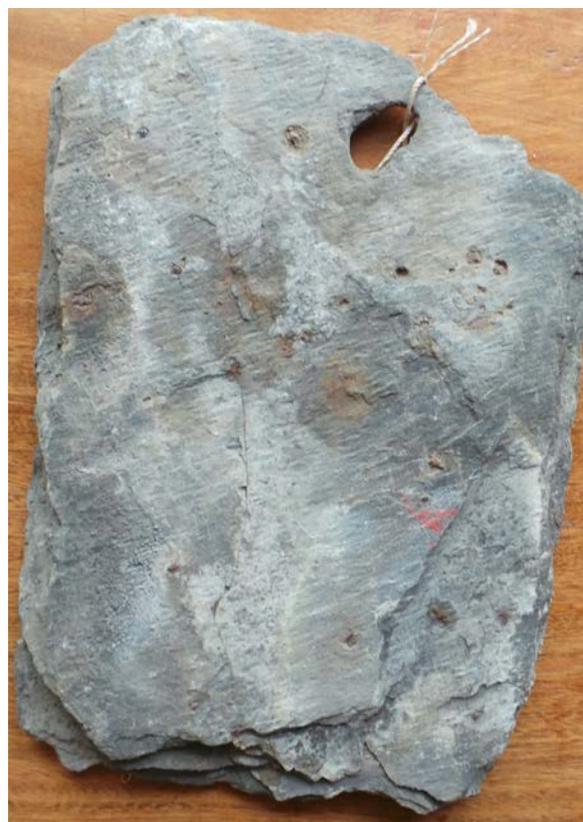
*Plate 22: Sample Context 8001 is a very irregular slate with large nail hole suitable for a wooden plug*

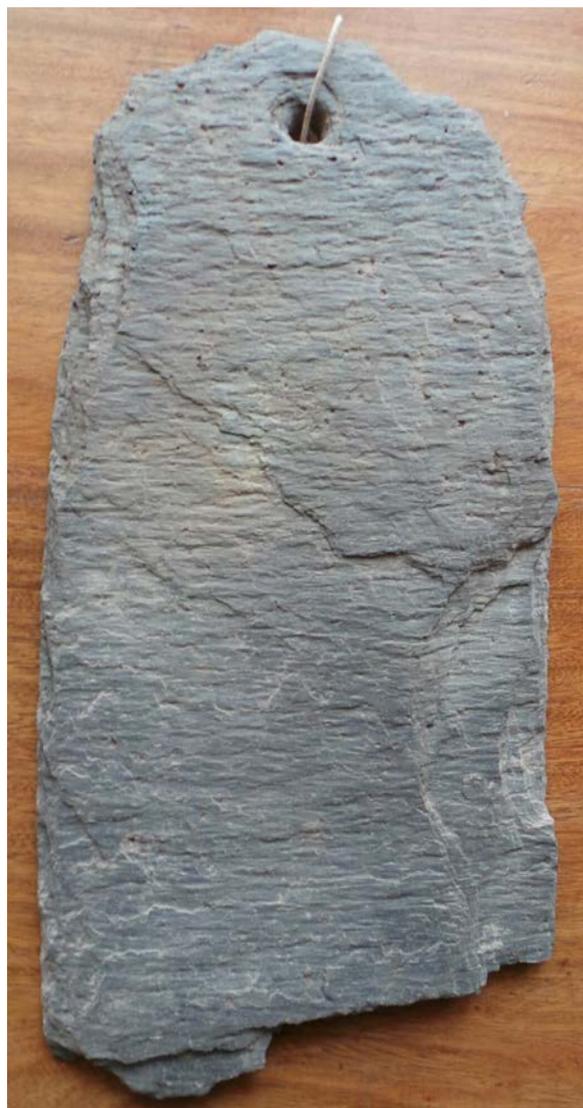
*Plate 23: Sample Context 8006C is a large slate with a fairly regular cleavage surface. There is a large nail hole suitable for a wooden plug*

a large hole for a wooden plug 15 mm in diameter (Plate 23).
